T-18 NEWSLETTER

The Flying Nut Contest Special

IN THIS ISSUE:

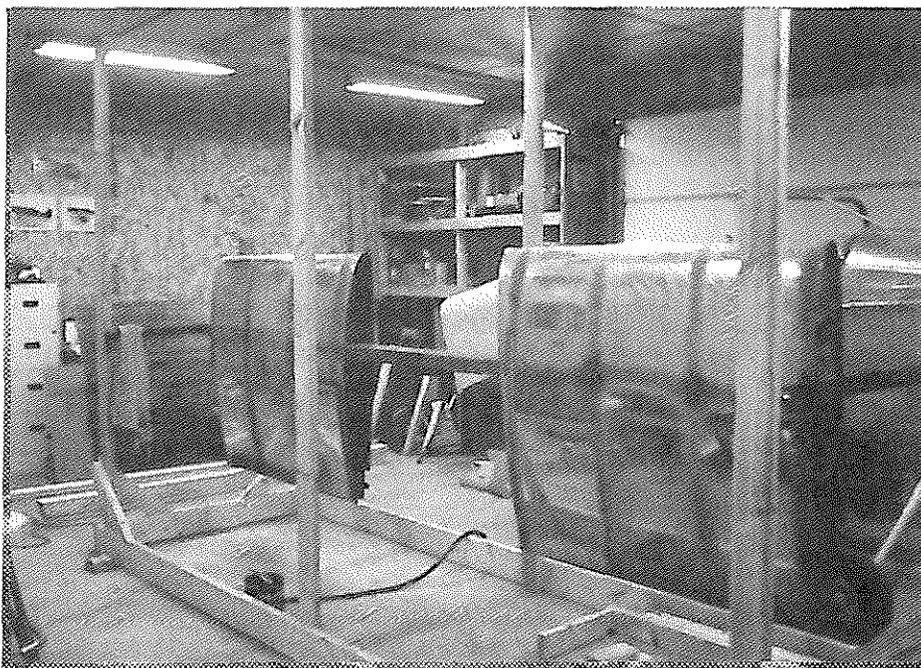
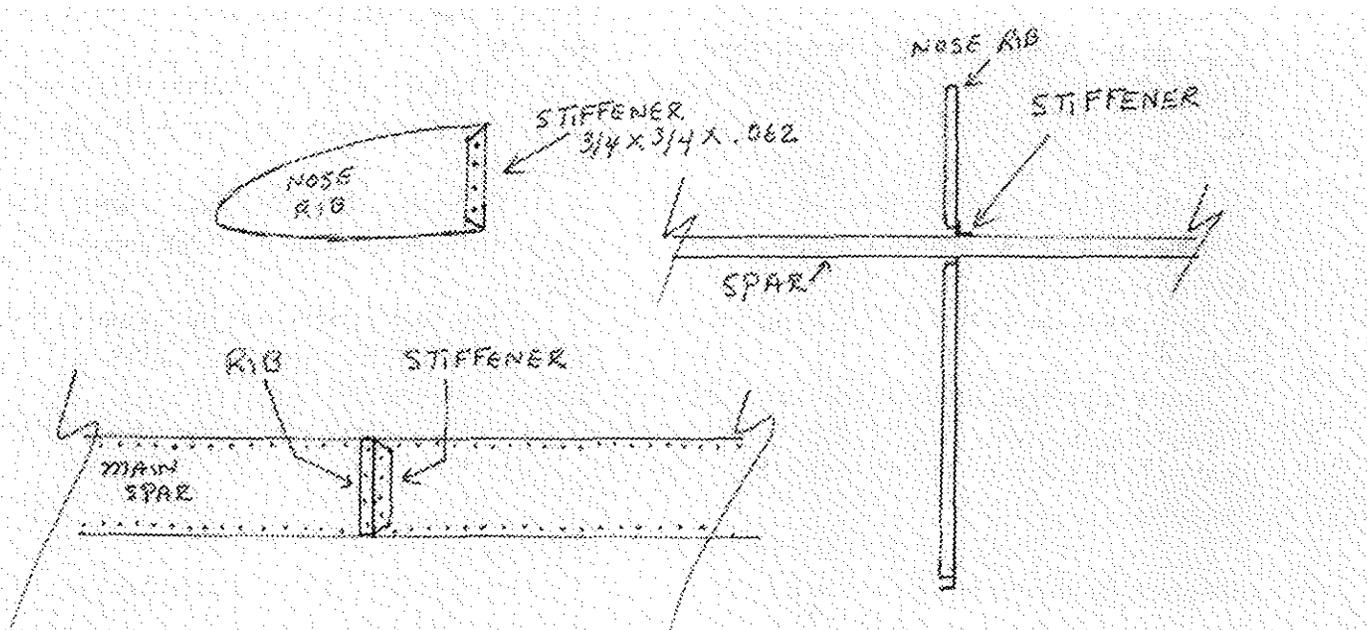
UPPER CORNER WHERE THE RIBS ATTACH TO THE MAIN SPAR. WHEN THE RIBS COMPRESS THIS CAUSES THE UPPER SKIN TO FORM A SMALL HUMP RIGHT IN FRONT OF THE MAIN SPAR. THIS "HUMP" IS PRESENT ON ALMOST ALL T-18'S THAT I HAVE SEEN. FROM WHAT I CAN GATHER, THE DEFORMATION IS CAUSED BY NORMAL WING LOADS, AND ONCE PRESENT NEVER SEEMS TO GET ANY WORSE. THE SOLUTION I BELIEVE IS RELATIVELY SIMPLE, HOWEVER, I DO NOT TAKE CREDIT FOR THE IDEA. I HAVEN'T HEARD OF ANYONE ELSE DOING IT, SO MAYBE I AM THE FIRST. THE FIX, IS TO ADD A $3/4 \times 3/4 \times .062$ ANGLE STIFFENER, BETWEEN EACH NOSE RIB AND THE MAIN SPAR. IT IS AN EASY PROCESS AND SHOULD ADD ENOUGH RIGIDITY TO THE RIBS TO PREVENT THEM FROM COMPRESSING. THE STIFFENERS RESEMBLE THE VERTICAL STIFFENERS THAT MOST OF US ADD TO THE CENTER WING MAIN SPAR. I'M NOT SURE, BUT I BELIEVE THAT THESE RIB STIFFENERS COULD DOUBLE AS THE VERTICAL SPAR STIFFENERS, THUS KILLING TWO BIRDS WITH ONE STONE. I ADDED THESE STIFFENERS TO EVERY NOSE RIB IN THE WING. FOR REASONS THAT I WON'T GET INTO, I NEEDED TO SPACE MY NOSE RIBS FORWARD BY .062" SO I WAS ABLE TO ATTACH MY STIFFENERS BETWEEN

THE RIB FLANGE AND THE SPAR. I ATTACHED THE STIFFENER TO THE RIB SIDE BY FOUR -4 RIVETS AND THEN TO THE SPAR USING THE RIBS OWN MOUNTING. ON THE OTHER HAND, THE STIFFENER COULD BE ATTACHED TO THE SPAR OPPOSITE THE RIB FLANGE, AGAIN ATTACHED TO THE RIB BY FOUR -4 RIVETS AND THEN SEPARATELY TO THE SPAR BY FOUR, -4 RIVETS. I HOPE MY EXPLANATION IS UNDERSTANDABLE, AND ALTHO MY DRAFTING SKILLS ARE NONEXISTENT I HAVE INCLUDED A COUPLE OF DRAWINGS OF THE RIB STIFFENER AND IT'S APPLICATION. LET ME KNOW WHAT YOU THINK. KEEP'M FLYING ROY FARRIS NOBLE, IL
